# The Local Oscillator

*The Newsletter of Crawford Broadcasting Company Corporate Engineering*

JUNE 2010 • VOLUME 21 • ISSUE 6 • W.C. ALEXANDER, CPBE, AMD, DRB EDITOR

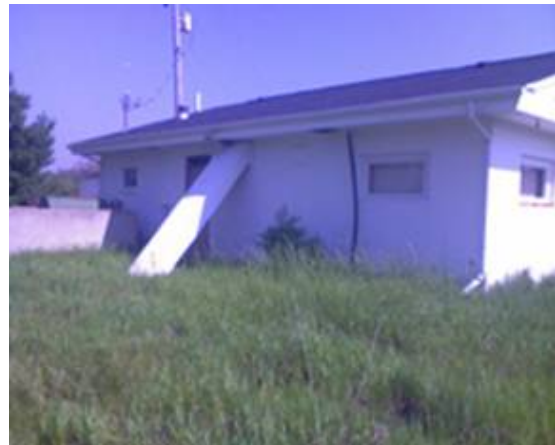
#### **Rear of WRDT transmitter building showing the new transmission line chase**

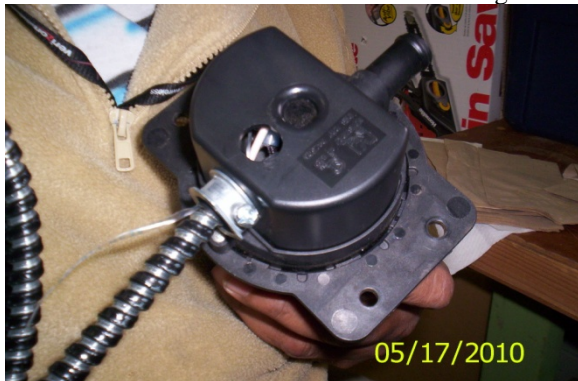
#### **BX cable was used to connect the block heater**

placement had to be just so, to keep the BX outer conductor away from the hot AC connection inside, but as you can see from the picture, Warren managed it and the old block heater is now back in place with its new armored AC connection. A new run of AC wiring was added going back to the AC breaker box inside the transmitter room. At the suggestion of the Cummins tech, we also added an on-off switch to the circuit to provide safety for the folks who have to work with the block heater and coolant in the future.

darn well mouse-proof to boot. So Warren jerked what was left of the line cord out of the block heater and cut a new hole in its base for the BX fitting. The
